Manhole Inspection Summary

Manhole # S29CC1020MH

Insp Date: **12/12/06 1:52 PM**

Location Address: **709 BERRY ST**

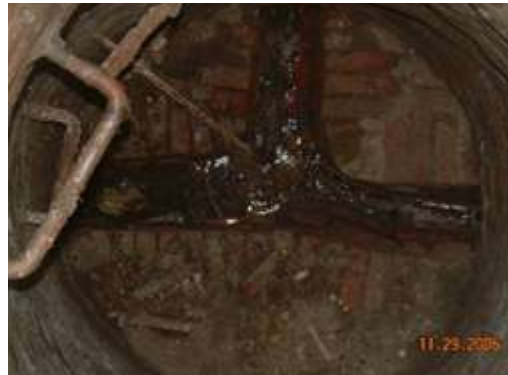
Top View

Evidence of surcharge - Bench debris.
Channel debris. Corroded steps.

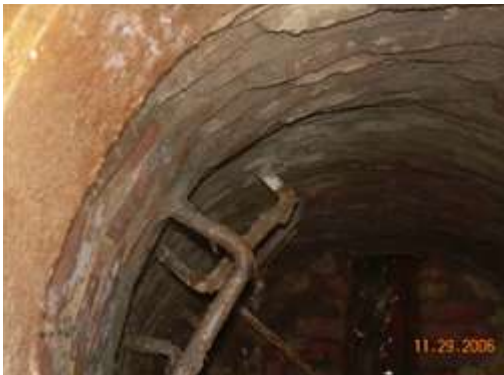
Defect

Adjustment, Corbel and Barrel infiltration.
Corroded steps.

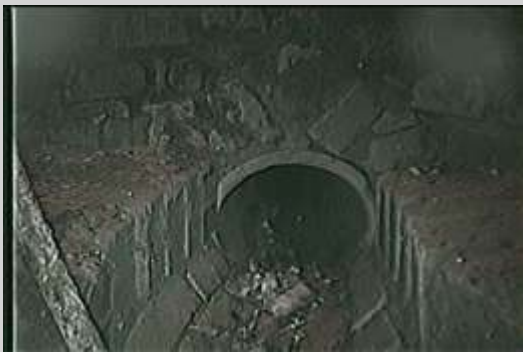
8 in. Circular Gravity Sewer Pipe Out @ 12 O'Clock

Deposits: ☐ None ☐ **Mud** ☐ Sludge ☒ **Debris** ☐ Grease

Silt Depth: **0** (in.) Deposits Extent: **Light**

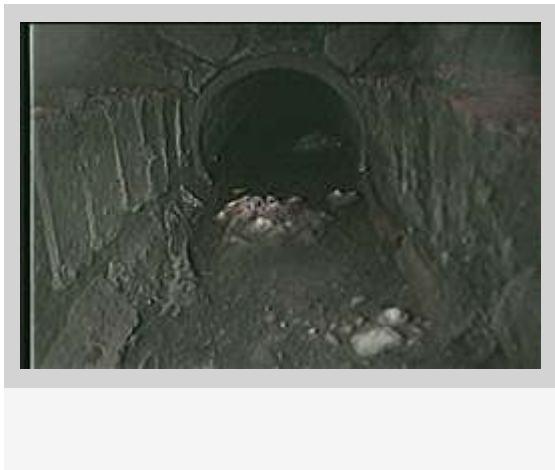
8 in. Circular Gravity Sewer
Pipe In @ 9 O'Clock

Deposits: ☐ None ☒ **Mud** ☐ Sludge ☒ **Debris** ☐ Grease

Silt Depth: **1** (in.) Deposits Extent: **Light**

Infiltration: **None** Pipe Seal Cond: **Cracked**
